NAVAL WEAPONS CENTER CHINA LAKE CALIF
COSO GEOTHERMAL CORROSION STUDIES.(U)

Coso Geothermal Corrosion Studies

by
Stephen A. Finnegan
Research Department

OCTOBER 1977

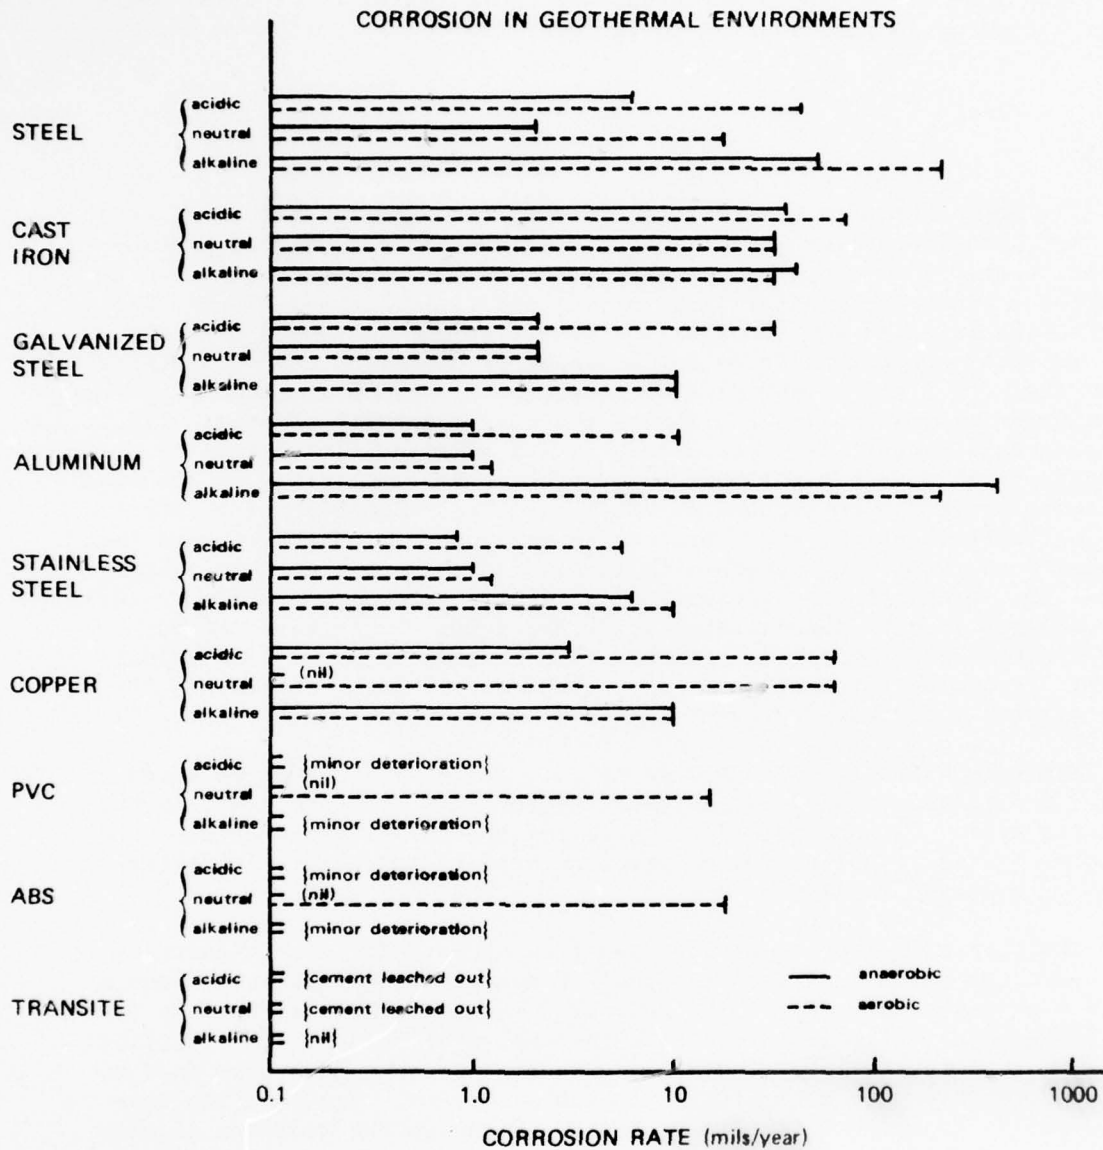
FIGURE 36. A Comparison of Corrosion Rates for Various Materials in Three Geothermal Fluids Found at the Coso Thermal Area.

Figure 36 compares corrosion rates for all of the materials studied in the three environments at the Coso Thermal Area, and under aerated and anaerobic test conditions. The comparisons that follow should be viewed for the most part as a rough guide when used for evaluating the performance of materials in the three Coso geothermal environments.

Reported here are results from a preliminary testing program on corrosion of selected engineering materials in various geothermal environments. Samples of nine different types of commercial pipe were exposed up to one year to three different geothermal fluids under anaerobic and aerobic conditions. The resulting corrosions were then examined by several techniques including ordinary microscopy, scanning electron microscopy and x-ray diffraction. Results were documented by a series of photographs, many of which are included in this report. A comprehensive summary of observed corrosion rates is presented graphically (Figure 36).
